Flood Control Project Maintenance
2018 Structure Summary Report
Overall Unit and Item Ratings

Plumas County

North Fork Feather River Diversion Channel Drop Structure No. 1

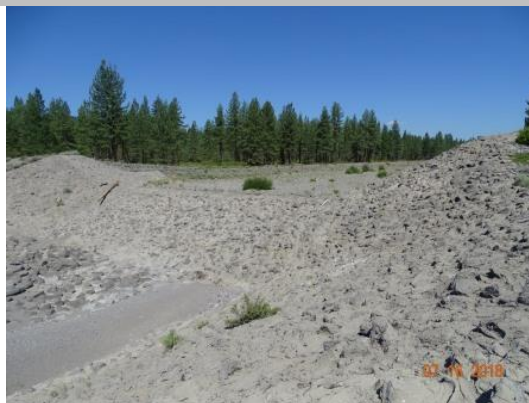
Photo 1 of 4 : ST_2018_NA0015_58_23_20180724_00006.jpg

LM Start	0.00	Rating **	N	Issue No.	23
LM End	0.00	Issue Type +	Ma	Location *	
Category	Structures & Concrete Lined Channels			GPS Latitude/Longitude	
				Start	End
Item	Photo Documentation			40.294270 °	40.294270 °
				-121.258935 °	-121.258935 °
DWR ID	DWR_NA0015_58_t_2012_23				
Action/Comments					
Inspector Comments: The channel needs to be sprayed or remove all vegetation from the channel, 2018.

View of Drop Structure 2 looking upstream, 2018.

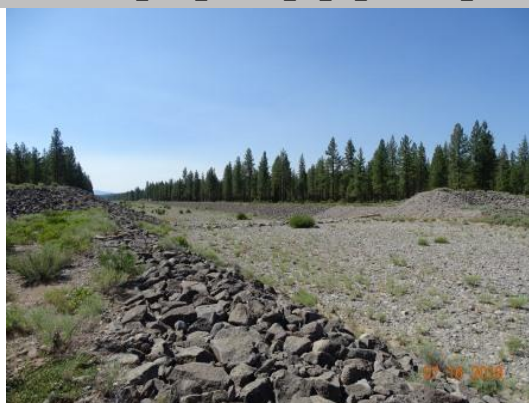
Photo 2 of 4 : ST_2018_NA0015_58_23_20180724_00007.jpg

View of Drop Structure 2 looking downstream, 2018.

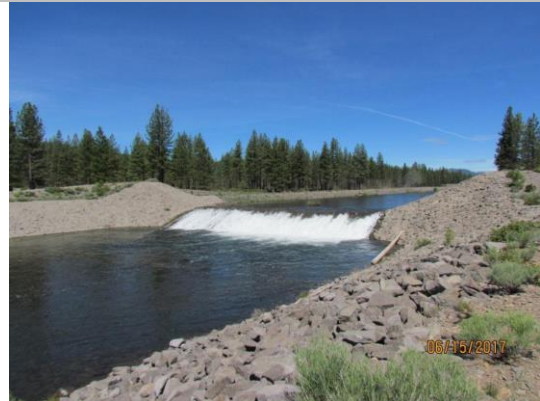
Photo 4 of 4 : ST_2018_NA0015_58_23_20180723_00002.jpg

LM Start	0.00	Rating **	N	Issue No.	23 (cont)	
LM End	0.00	Issue Type +	Ma	Location *		
Category	Structures & Concrete Lined Channels			GPS Latitude/Longitude		
				Start		End
Item	Photo Documentation			40.294270 °		40.294270 °
				-121.258935 °		-121.258935 °
DWR ID	DWR_NA0015_58_t_2012_23					
Action/Comments						
Inspector Comments: The channel needs to be sprayed or remove all vegetation from the channel, 2018.

View of drop structure 2, with water flowing over the structure during the inspection.

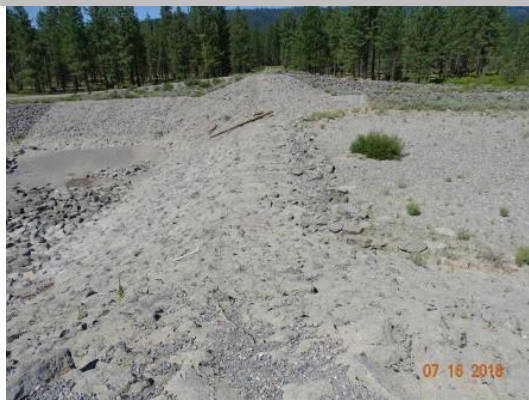
Photo 1 of 1 : ST_2018_NA0015_58_4_20180724_00005.jpg

LM Start	0.00	Rating **	A	Issue No.	4
LM End	0.00	Issue Type +	Ma	Location *	
Category	Structures & Concrete Lined Channels			GPS Latitude/Longitude	
				Start	End
Item	Revetments			40.294270 °	40.294270 °
				-121.258935 °	-121.258935 °
DWR ID	DWR_NA0015_58_t_2012_4				
Action/Comments					
Inspector Comments: Existing riprap protection is properly maintained.

View looking across the drop structure from the left bank at the well maintained concreted revetment, 2018.

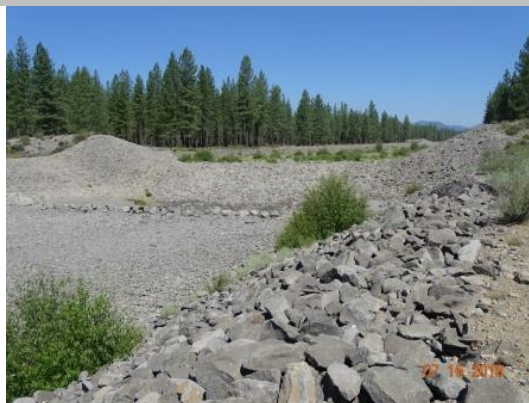
Photo 1 of 2 : ST_2018_NA0015_59_23_20180724_00007.jpg

LM Start	0.00	Rating **	N	Issue No.	23
LM End		Issue Type +	Ma	Location *	
Category	Structures & Concrete Lined Channels			GPS Latitude/Longitude	
				Start	End
Item	Photo Documentation			40.289767 °	40.289767 °
				-121.256375 °	-121.256375 °
DWR ID	DWR_NA0015_59_t_2012_23				
Action/Comments					
Inspector Comments: The channel needs to be sprayed or remove all vegetation from the channel, 2018.

View looking upstream at Drop Structure 3, 2018.

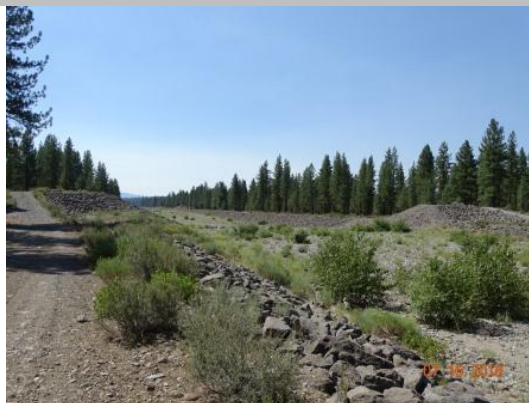
Photo 2 of 2 : ST_2018_NA0015_59_23_20180724_00006.jpg

View looking downstream at Drop Structure 3, 2018.

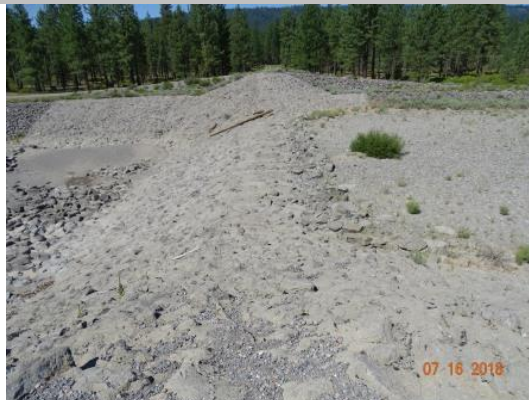
Photo 1 of 1 : ST_2018_NA0015_59_4_20180724_00005.jpg

LM Start	0.00	Rating **	A	Issue No.	4
LM End	0.00	Issue Type +	Ma	Location *	
Category	Structures & Concrete Lined Channels	GPS Latitude/Longitude			
		Start		End	
Item	Revetments	40.289767 °		40.289767 °	
		-121.256375 °		-121.256375 °	
DWR ID	DWR_NA0015_59_t_2012_4				
Action/Comments					
Inspector Comments: Existing riprap protection is properly maintained, 2018.

View looking across the drop structure from the left bank at the well maintained concreted revetment, 2018.

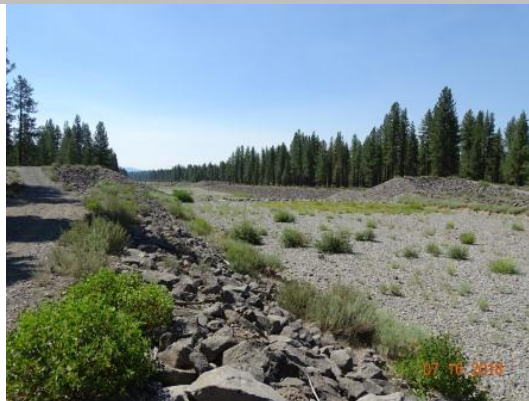
Photo 1 of 2 : ST_2018_NA0015_60_23_20180724_00007.jpg

LM Start	0.00	Rating **	N	Issue No.	23
LM End	0.00	Issue Type +	Ma	Location *	
Category	Structures & Concrete Lined Channels			GPS Latitude/Longitude	
				Start	End
Item	Photo Documentation			40.285653 °	40.285653 °
				-121.253902 °	-121.253902 °
DWR ID	DWR_NA0015_60_t_2012_23				
Action/Comments					
Inspector Comments: The channel needs to be sprayed or remove all vegetation from the channel, 2018.

View looking downstream at Drop Structure 4, 2018.

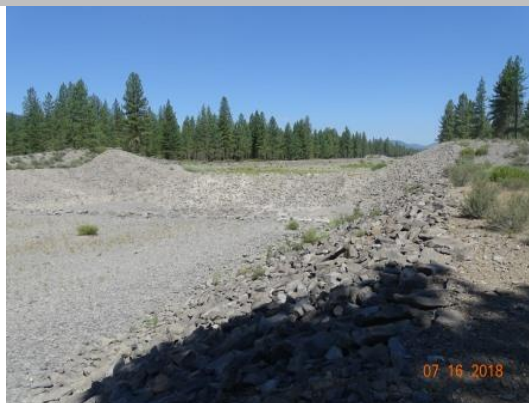
Photo 2 of 2 : ST_2018_NA0015_60_23_20180724_00008.jpg

View looking upstream at Drop Structure 4, 2018.

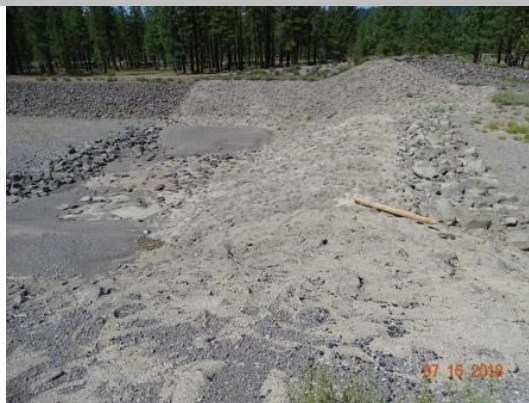
Photo 1 of 1 : ST_2018_NA0015_60_4_20180724_00005.jpg

LM Start	0.00	Rating **	A	Issue No.	4
LM End	0.00	Issue Type +	Ma	Location *	
Category	Structures & Concrete Lined Channels			GPS Latitude/Longitude	
				Start	End
Item	Revetments			40.285653 °	40.285653 °
				-121.253902 °	-121.253902 °
DWR ID	DWR_NA0015_60_t_2012_4				
Action/Comments					
Inspector Comments: Existing riprap protection is properly maintained.

View looking across the drop structure from the left bank at the well maintained concreted revetment, 2018.

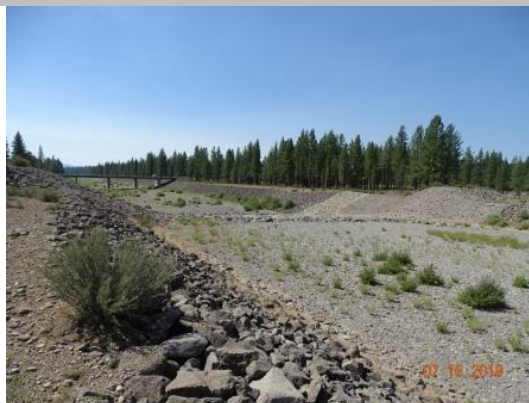
Photo 1 of 2 : ST_2018_NA0015_61_23_20180724_00006.jpg

LM Start	0.00	Rating **	N	Issue No.	23
LM End	0.00	Issue Type +	Ma	Location *	
Category	Structures & Concrete Lined Channels			GPS Latitude/Longitude	
				Start	End
Item	Photo Documentation			40.283028 °	40.283028 °
				-121.252348 °	-121.252348 °
DWR ID	DWR_NA0015_61_t_2012_23				
Action/Comments					
Inspector Comments: The channel needs to be sprayed or remove all vegetation from the channel, 2018.

View looking downstream at Drop Structure 5, 2018.

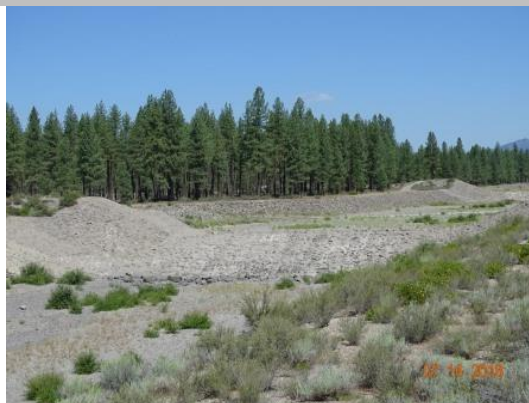
Photo 2 of 2 : ST_2018_NA0015_61_23_20180724_00007.jpg

View looking upstream at Drop Structure 5, 2018.

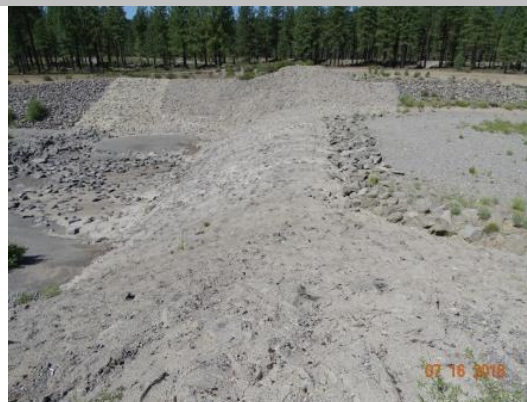
Photo 1 of 1 : ST_2018_NA0015_61_4_20180724_00008.jpg

LM Start	0.00	Rating **	A	Issue No.	4
LM End	0.00	Issue Type +	Ma	Location *	
Category	Structures & Concrete Lined Channels	GPS Latitude/Longitude			
		Start		End	
Item	Revetments	40.283028 °		40.283028 °	
		-121.252348 °		-121.252348 °	
DWR ID	DWR_NA0015_61_t_2012_4				
Action/Comments					
Inspector Comments: Existing riprap protection is properly maintained.

View looking across the drop structure from the left bank at the well maintained concreted revetment, 2018.

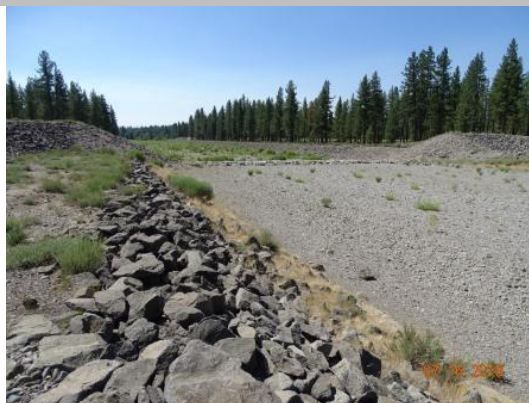
Photo 1 of 2 : ST_2018_NA0015_62_23_20180724_00006.jpg

LM Start	0.00	Rating **	N	Issue No.	23
LM End	0.00	Issue Type +	Ma	Location *	
Category	Structures & Concrete Lined Channels			GPS Latitude/Longitude	
				Start	End
Item	Photo Documentation			40.275902 °	40.275902 °
				-121.248142 °	-121.248142 °
DWR ID	DWR_NA0015_62_t_2012_23				
Action/Comments					
Inspector Comments: The channel needs to be sprayed or remove all vegetation from the channel.

View looking downstream at Drop Structure 6, 2018.

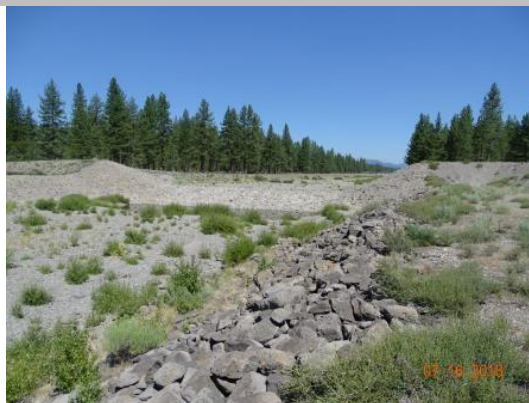
Photo 2 of 2 : ST_2018_NA0015_62_23_20180724_00007.jpg

View looking upstream at Drop Structure 6, 2018.

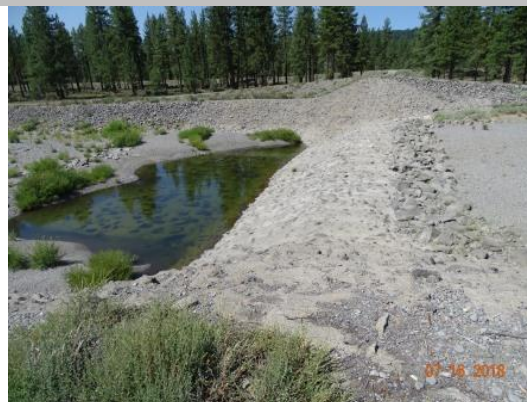
Photo 1 of 1 : ST_2018_NA0015_62_4_20180724_00005.jpg

LM Start	0.00	Rating **	A	Issue No.	4
LM End	0.00	Issue Type +	Ma	Location *	
Category	Structures & Concrete Lined Channels			GPS Latitude/Longitude	
				Start	End
Item	Revetments			40.275902 °	40.275902 °
				-121.248142 °	-121.248142 °
DWR ID	DWR_NA0015_62_t_2012_4				
Action/Comments					
Inspector Comments: Existing riprap protection is properly maintained.

View looking across the drop structure from the left bank at the well maintained concreted revetment, 2018.

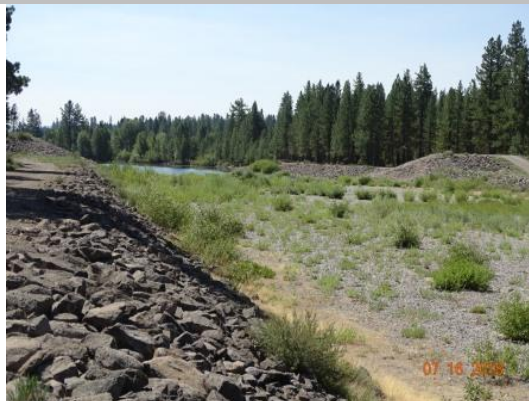
Photo 1 of 2 : ST_2018_NA0015_63_23_20180724_00006.jpg

LM Start	0.00	Rating **	N	Issue No.	23
LM End	0.00	Issue Type +	Ma	Location *	
Category	Structures & Concrete Lined Channels			GPS Latitude/Longitude	
				Start	End
Item	Photo Documentation			40.272544 °	40.272544 °
				-121.246161 °	-121.246161 °
DWR ID	DWR_NA0015_63_t_2015_23				
Action/Comments					
Inspector Comments: The channel needs to be sprayed or have all vegetation removed from the channel (2018).

View looking downstream at Drop Structure 7, 2018.

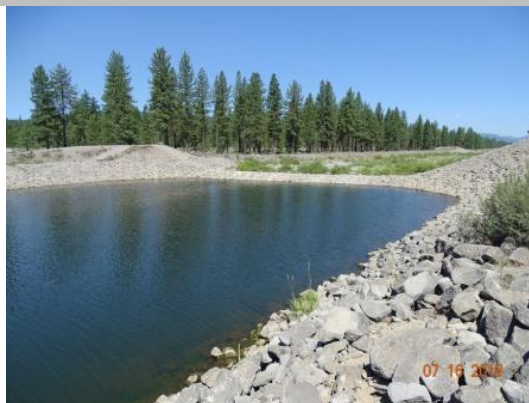
Photo 2 of 2 : ST_2018_NA0015_63_23_20180724_00007.jpg

View looking upstream at Drop Structure 7, 2018.

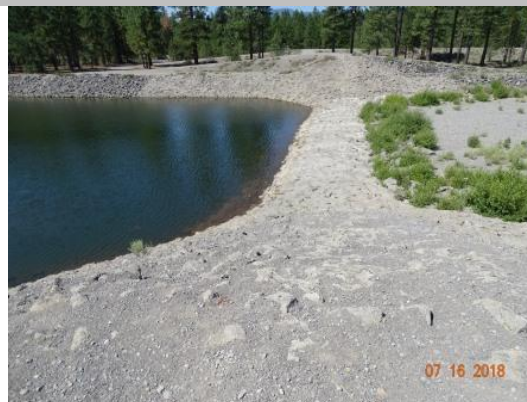
Photo 1 of 1 : ST_2018_NA0015_63_4_20180724_00005.jpg

LM Start	0.00	Rating **	A	Issue No.	4	
LM End	0.00	Issue Type +	Ma	Location *		
Category	Structures & Concrete Lined Channels			GPS Latitude/Longitude		
				Start		End
Item	Revetments			40.272544 °		40.272544 °
				-121.246161 °		-121.246161 °
DWR ID	DWR_NA0015_63_t_2012_4					
Action/Comments						
Inspector Comments: Existing riprap protection is properly maintained.

View looking across the drop structure from the left bank at the well maintained concreted revetment, 2018.

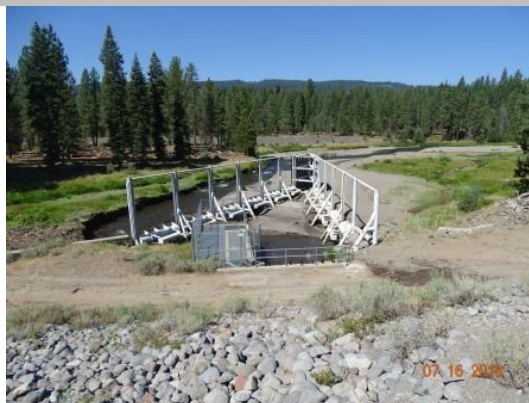
Photo 1 of 3 : ST_2018_NA0015_37_23_20180725_00014.jpg

View of the dam intake and debris diversion structure, 2018.

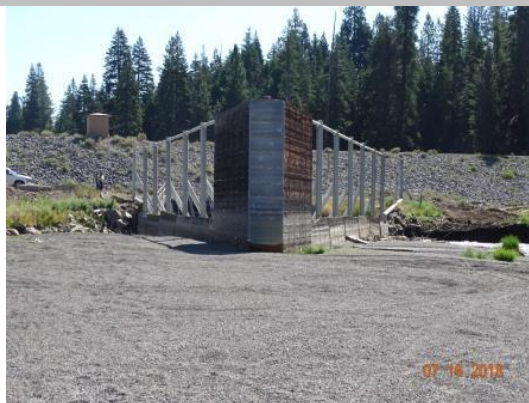
Photo 2 of 3 : ST_2018_NA0015_37_23_20180725_00013.jpg

View of the dam and structure from the inlet, 2018.

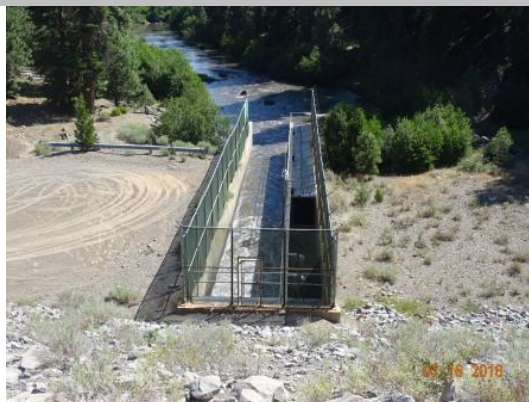
Photo 3 of 3 : ST_2018_NA0015_37_23_20180725_00015.jpg

View of the outfall structure from the top of the dam, 2018.
